Hadrian's Wall

English Heritage Guidebooks

The north-west frontier of the Roman empire

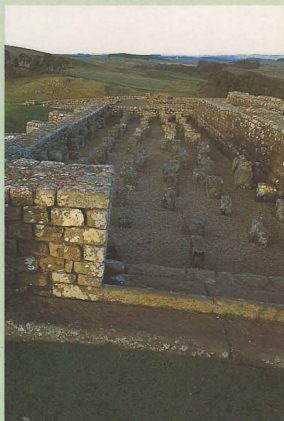
Granary at Housesteads High on a ridge, the fort at Housesteads is one of the iconic sites of the Roman empire. It was occupied for almost 300 years, and the exposed remains, including the headquarters building, hospital, commanding officer's house and barrack blocks, are of different periods.

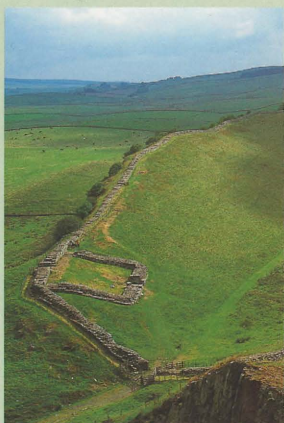
Milecastle 42 These guardposts were built at intervals of one Roman mile to control movement across the Wall. This one at Cawfields clings to the hillside within a particularly spectacular stretch of landscape. It was excavated 150 years ago by John Clayton of Chesters.

Cawfields milecastle (42) has yielded an inscription recording that it was built by the Second Legion Augusta. The massive masonry employed in the gates appears to be the hallmark of this legion. To the south is a fine stretch of the Vallum. The Wall runs on past Thorny Doors, where it stands 13 courses high, to Caw Gap turret (41a). This was demolished in the late second century and only the lowest courses survive.

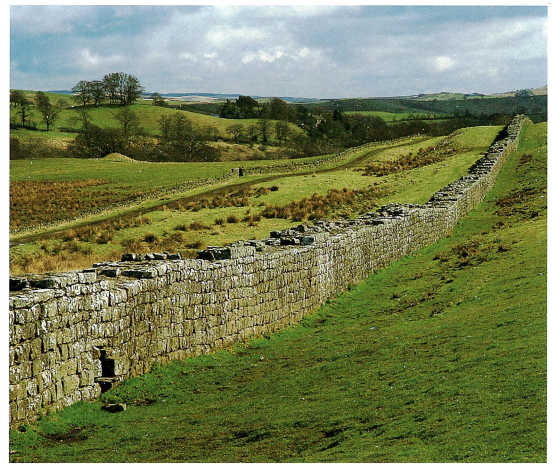
Above: A phallic symbol on the south face of the Wall between Harrow's Scar milecastle and Birdoswald fort. It represented protection against evil

Above right: Hadrian's Wall running eastwards from Birdoswald to Harrow's Scar is the longest visible stretch of Wall rebuilt in stone

Right: Banks East turret (52a)

From Banks to Birdoswald, the remains lie beside the modern road. The first three visible turrets were built freestanding to receive the turf wall at each side: they are now abutted by the later stone wall. On the rise to the east of Turret 52a (Banks East) lies a fragment of an earlier observation tower; Pike Hill. Before the Wall was built, the troops posted here communicated back to the forts on the road to the south, the Stanegate. The last visible turret (49b) is a later (but still Hadrianic) stone wall turret, bonded in with the Wall.

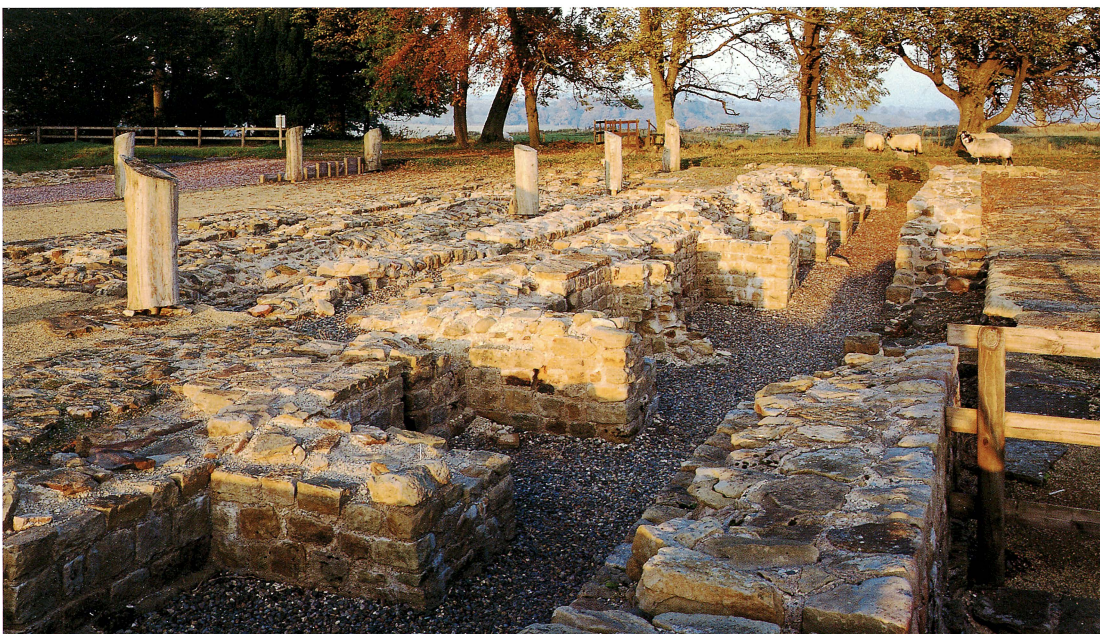
Left: The demolished north granary was replaced by a timber hall rather larger than the granary. The pillars of the hall are marked by modern posts

Granaries The two granaries were built in the early third century. In the later fourth century, both buildings were given over to other uses. The northern one was demolished and replaced by a timber hall, now marked by large posts. To the north of the granaries, and across the main street, lie the remains of a workshop or store.

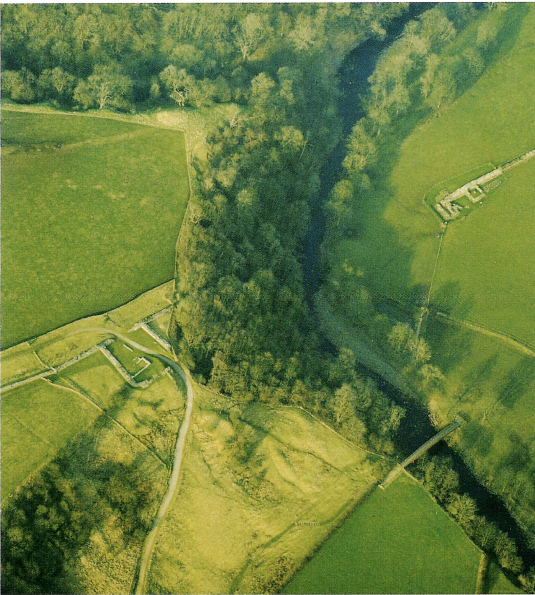
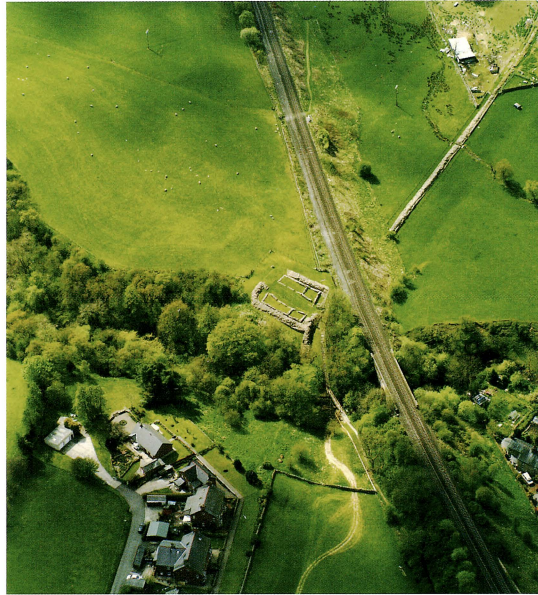
Far left: Harrow's Scar milecastle (49) from the air, with the east abutment of Willowford Bridge to its right
Left: Poltross Burn milecastle (48) from the air looking east. The steps (seen below left) allow the height of the milecastle wall, and possibly therefore Hadrian's Wall itself, to be calculated as 4m
Below: Walltown turret (45A)
Bottom: Cawfields milecastle (42)

Poltross Burn milecastle (48) is larger than usual and contains the remains of two barrack-blocks. The north gate was narrowed, probably in the third century. In the north-west corner, the remains of several successive ovens survive, and in the north-east a flight of steps. Projecting these upwards indicates that the Wall was 3.66m high measured from inside the milecastle and 4m on the outside.

The Roman Army Museum stands beside the fort at Carvoran, only visible as earthworks. Quarrying damaged the next stretch of Wall, but it still contains two turrets, both unique. Walltown turret (45a) was constructed before the Wall, which abuts it on each side. Mucklebank turret (44b) sits in a corner of the Wall.

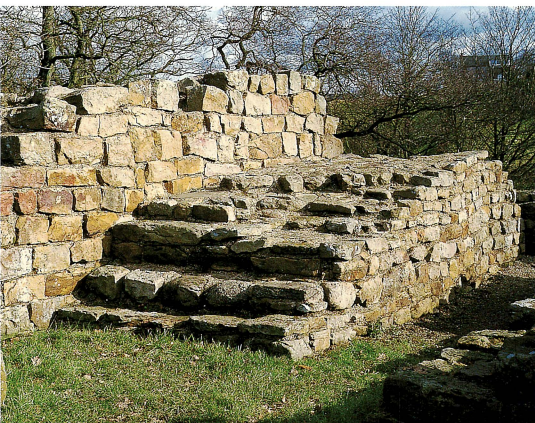
The intention was to build the next mile of Wall at a width of 10 Roman feet. In places, the lower courses of this Wall can be seen, with its

narrower successor sitting on top: this change took place during the reign of Hadrian. At the two turrets (48b and 48a), a vertical point of reduction from broad to narrow wall occurs.

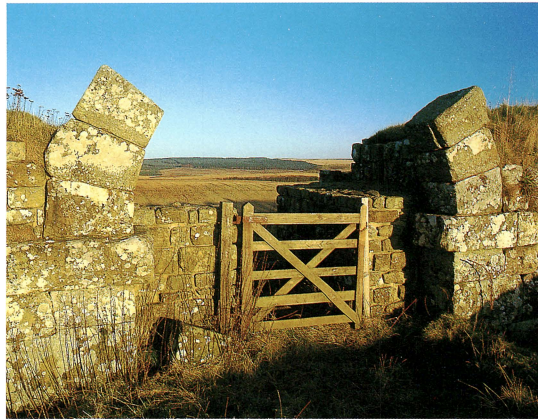
Left: The north gate of Housesteads milecastle. Some of the arch stones have been replaced

been robbed out, but the site is easily recognisable. A mile on is Housesteads milecastle (37), one of the best-preserved milecastles. Inscriptions found at these two milecastles demonstrate that they were built by the Second Legion. The gates are of the same massive masonry seen at Cawfields milecastle. The north gate is the better-preserved, with some of the arch stone re-erected. The east half of the enclosure was occupied by a stone-built barrack. The back wall of the building does not exist; it has either been destroyed, or the building rested against the inside face of the milecastle wall. The building is large enough to have housed eight men. A short road connected the milecastle to the Military Way to the south. Either this track or the Wall can be followed to Housesteads fort.

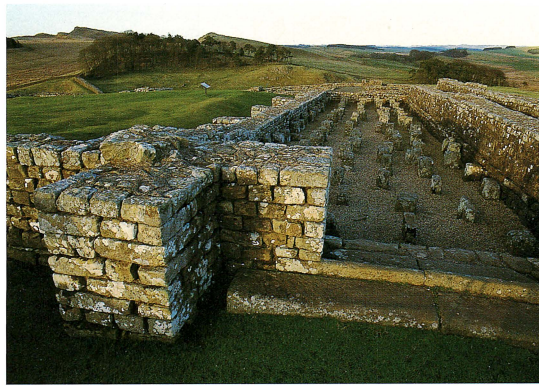
Left: The north granary at Housesteads

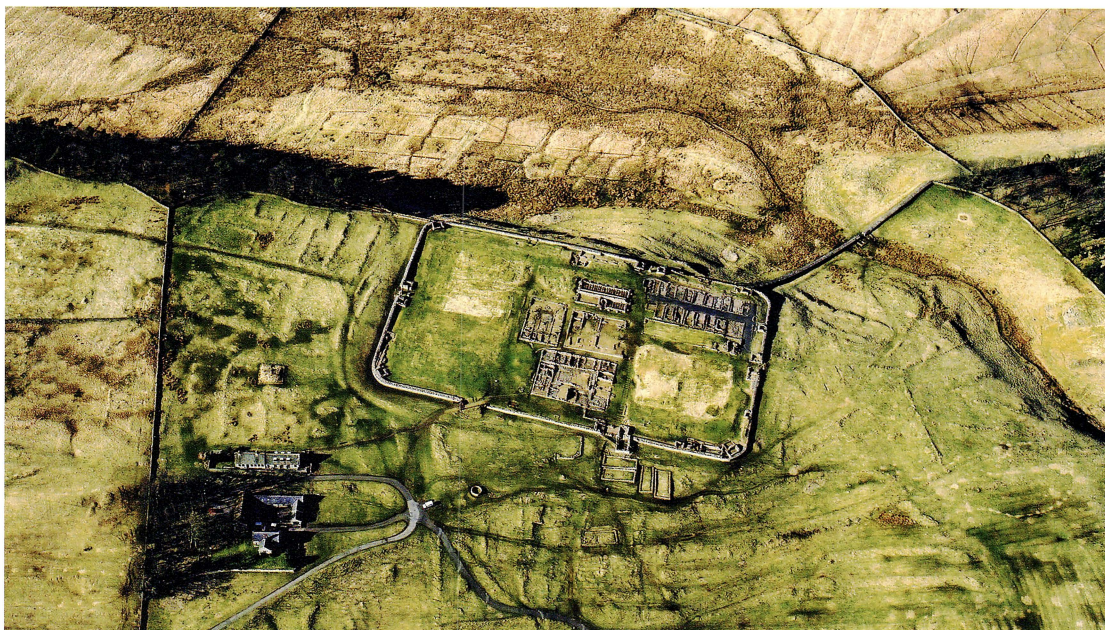
Right: Housesteads fort from the air, looking north

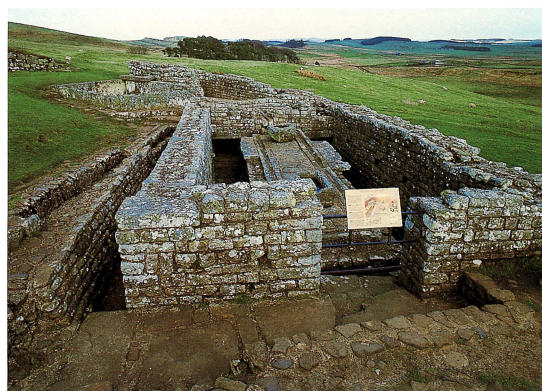
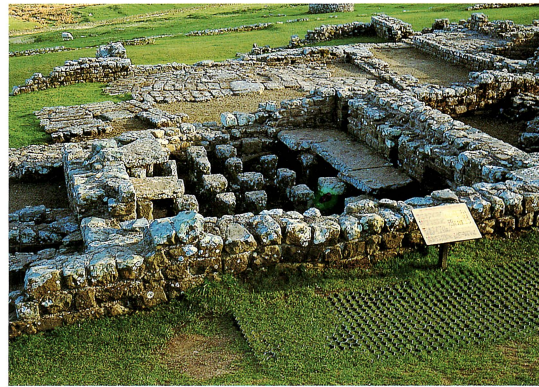
Far right: The latrine today

Latrine Carefully placed at the lowest point of the fort, the latrine was fed by water from various tanks. Wooden seats would have covered the main sewer channel. The smaller channel on the platform was used for washing the sponges used instead of paper. A drain carried the sewage

from the corner of the fort down the hill side.

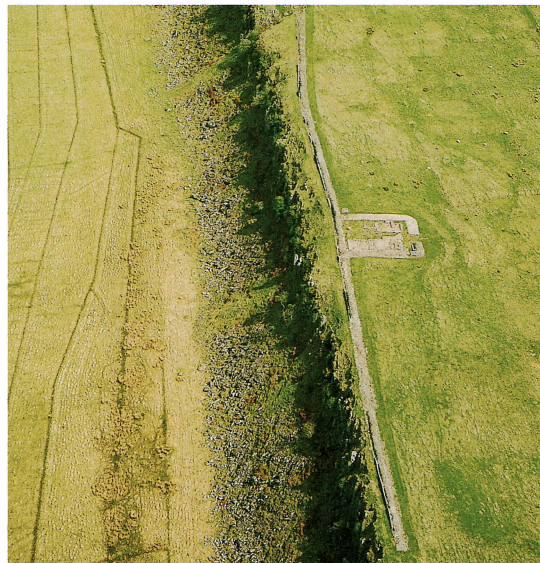
Above: Turret 33b looking east. This turret went out of use in the later second century. At first the door was blocked and then the turret was demolished down to the bottom four courses, and the recess on the north side blocked up

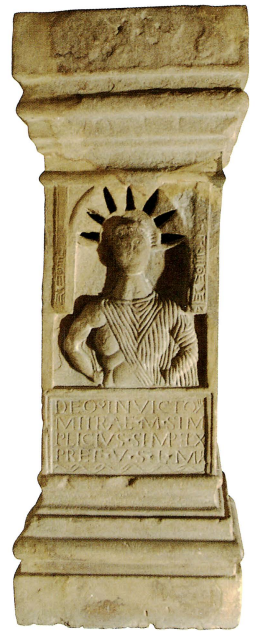
Above: An altar to Mithras from the mithraeum. A lamp placed in the recess at the rear would light up the rays

Cautes and Cautopates guard the nave: they were supporters of Mithras. Here benches lie on either side of a central passage on which worshippers would recline during ceremonies. At the far end of the nave is the sanctuary containing the altars. On one altar, Mithras appears as the Charioteer of the Sun; this stone has been carved out so that a lamp placed in the hollow behind will cause the rays to light up.

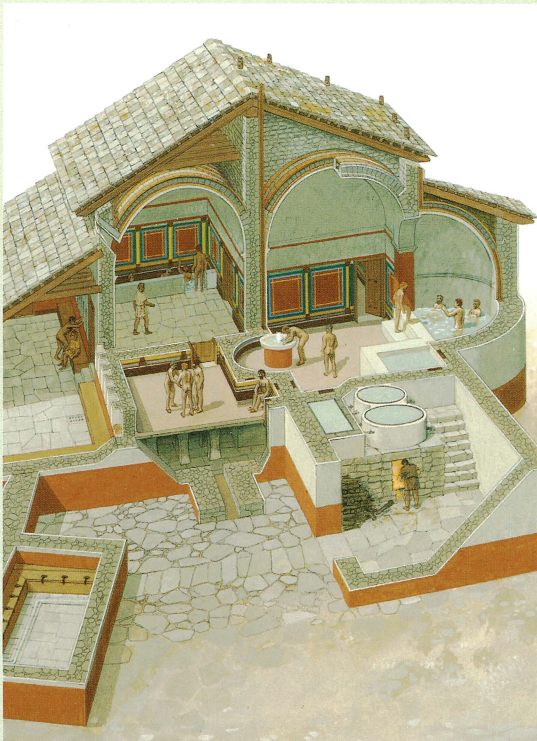
Below: A cutaway reconstruction of the bath house at Vindolanda, showing the methods of heating the floors and the walls. A replica of Chesters bath house can be seen at Wallsend (see page 33)

Many bath houses offered two forms of bathing: the steam treatment or Turkish bath (so-called because the Turks took it over when they conquered Constantinople), and the hot, dry bath or sauna. Soldiers first entered the changing room, and then had the choice. Each room was hotter than the last, the final room being above the furnace. The fires here heated the basement below the floors, so sandals had to be worn. The hot air passed through vents up the walls to escape at the roof. The soldiers could recline on the stone benches, and perhaps play board games. Their bodies would be anointed with oil, and the dirt and oil scraped off with a blunt knife or strigil. After such treatment, the soldier could take a dip in the cold bath before returning to the fort.

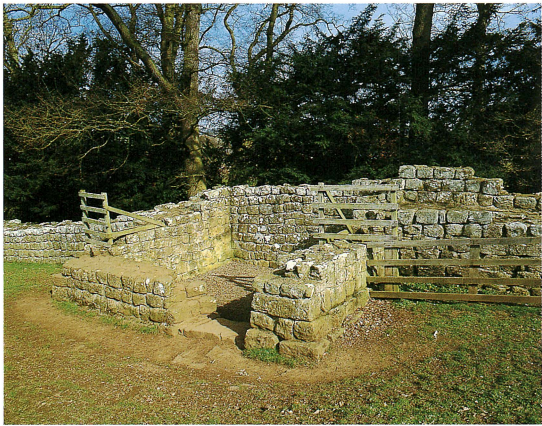
Above: The bridge abutment at Chesters

Across the river from Chesters fort, and accessible from the east side of the modern bridge, lies the east abutment of the bridge over the River North Tyne. There are two main phases to the bridge. A pier embedded in this abutment probably formed part of the Hadrianic bridge. This is thought to have had eight stone piers supporting stone arches. The position of the robbed east abutment of the bridge and a section of the paved riverbed can be seen in the bottom of the later tower:

The visible abutment, built in the later second century, carried a road (now removed) over the river. This bridge probably contained four arches and stood 10m above the water. Many carved stones from the superstructure of this bridge

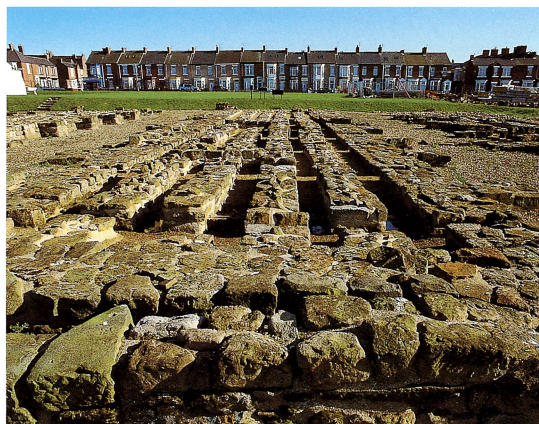
Right: The granaries. These were turned into barrack blocks in the fourth century

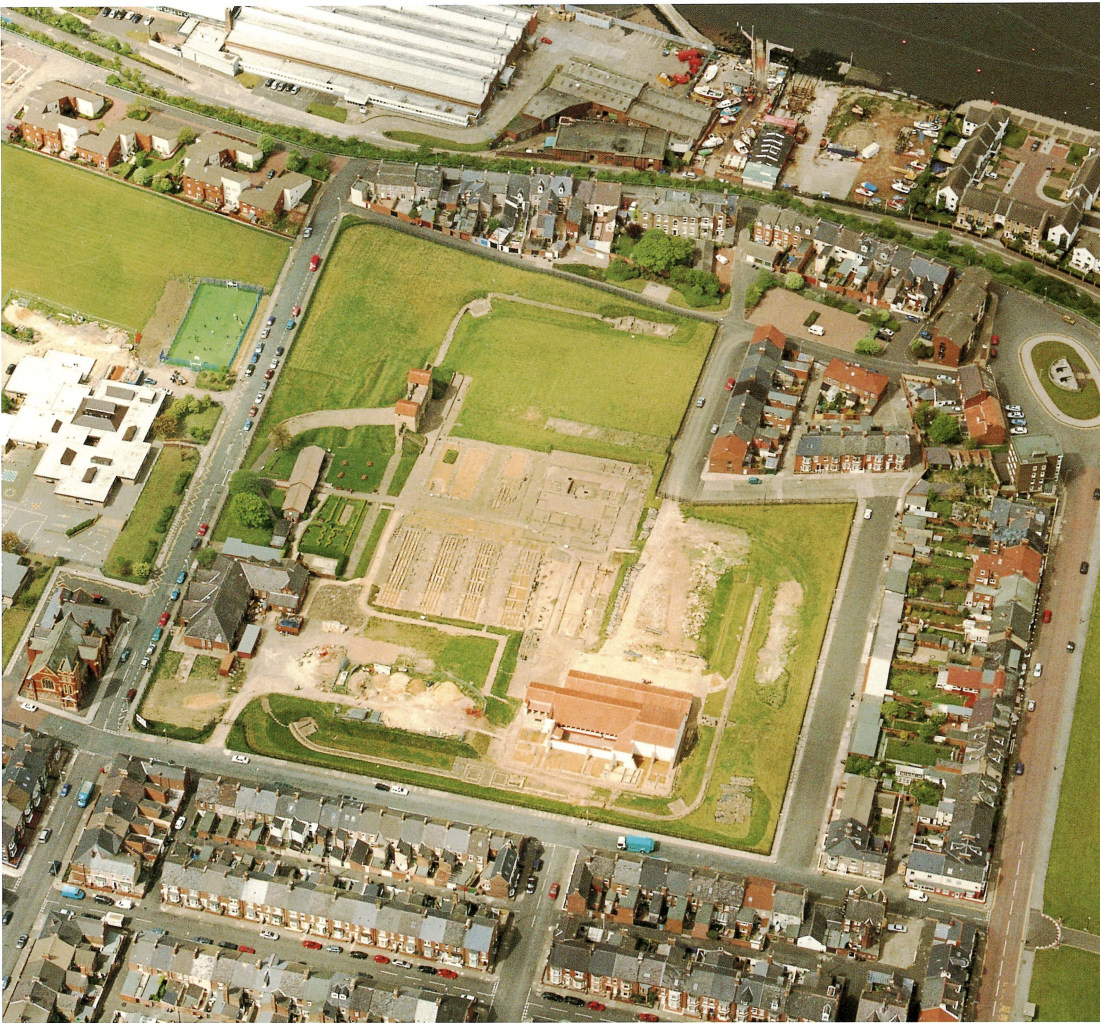
Left: South Shields from the air, looking north. The partially restored courtyard house is in the foreground, with the reconstructed west gate to the left

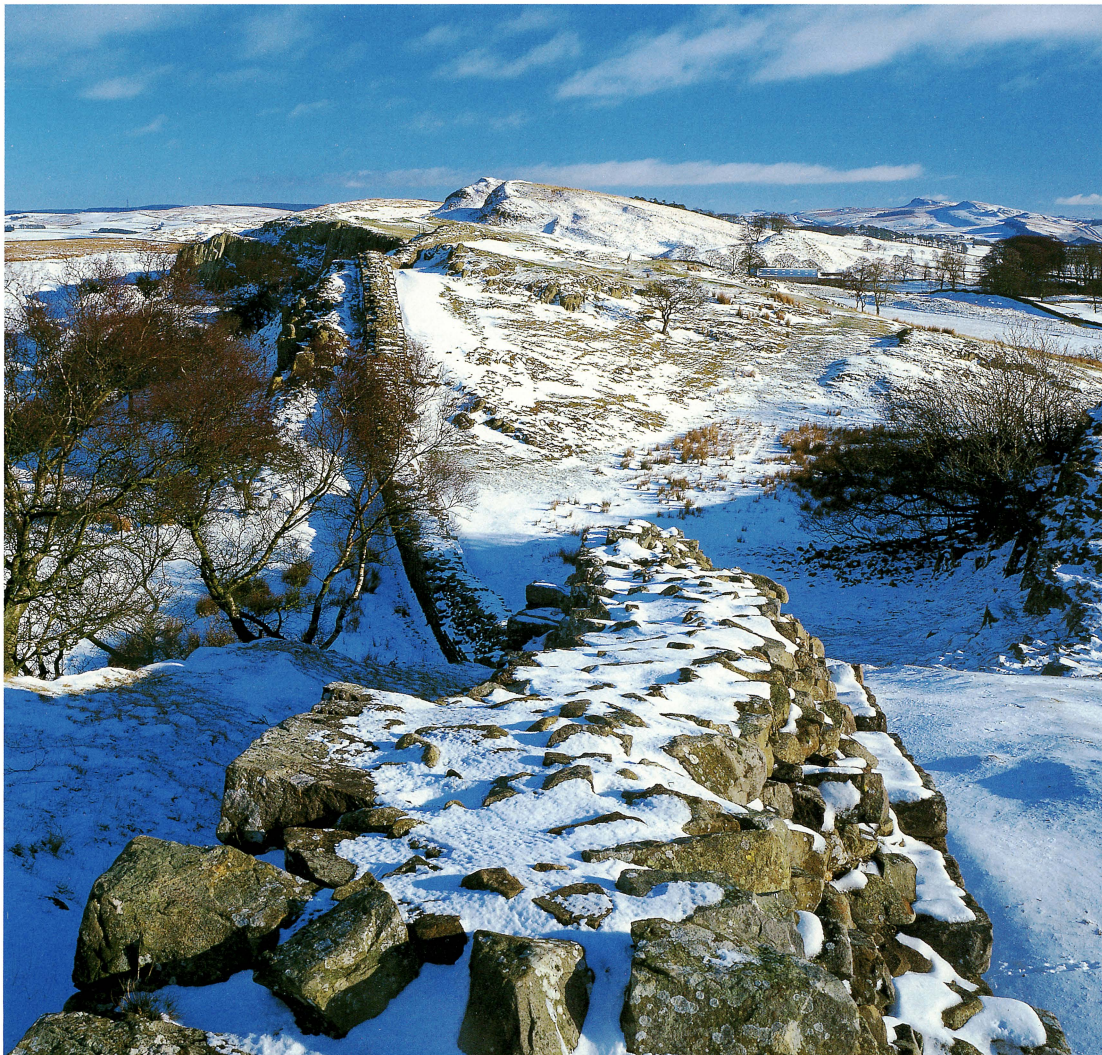
Left: Hadrian's Wall at Walltown Crags, in the central sector

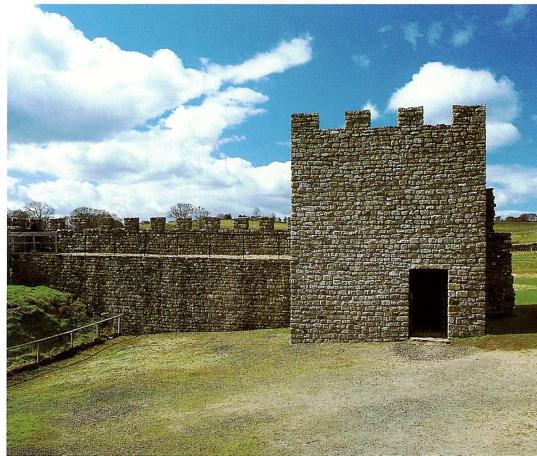
Left: The replica turret at Vindolanda

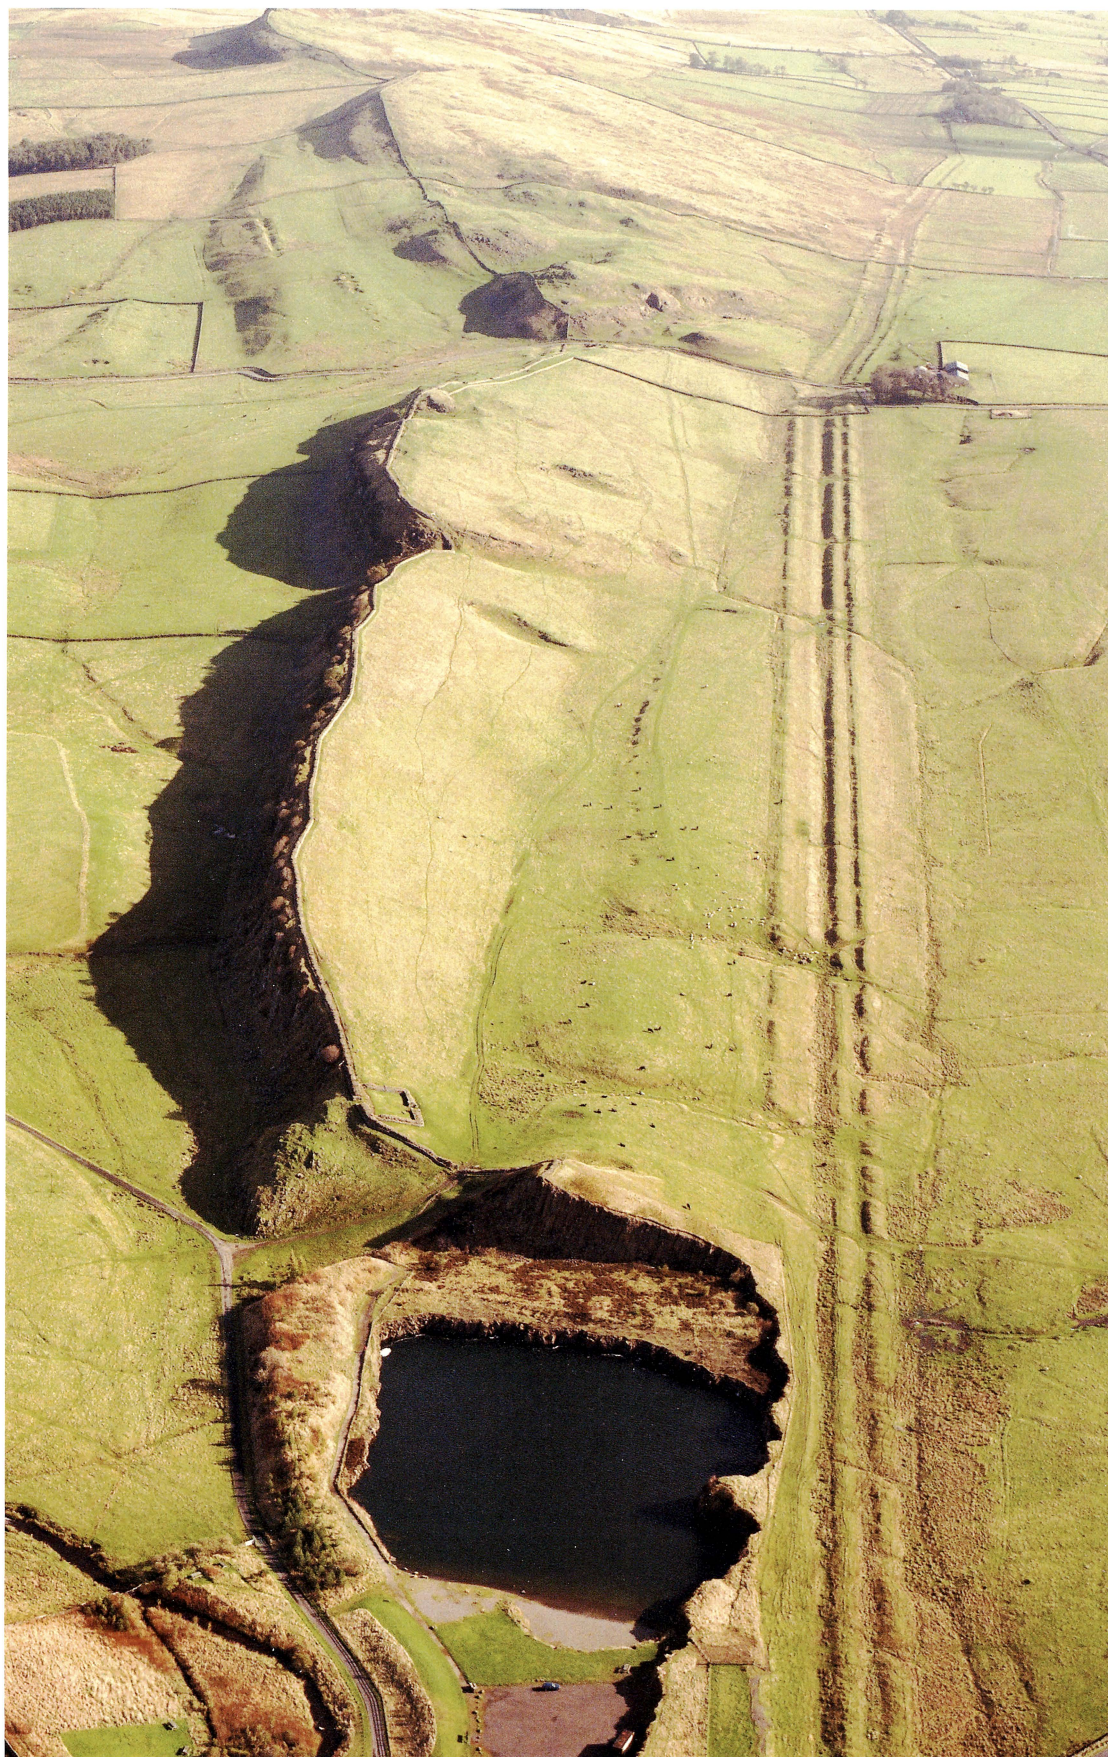
Right: Hadrian's Wall at Cawfields, from the air looking east. Cawfields milecastle (42) lies beside the quarry and the Wall runs on along the crags. The vallum follows the easier ground to the right

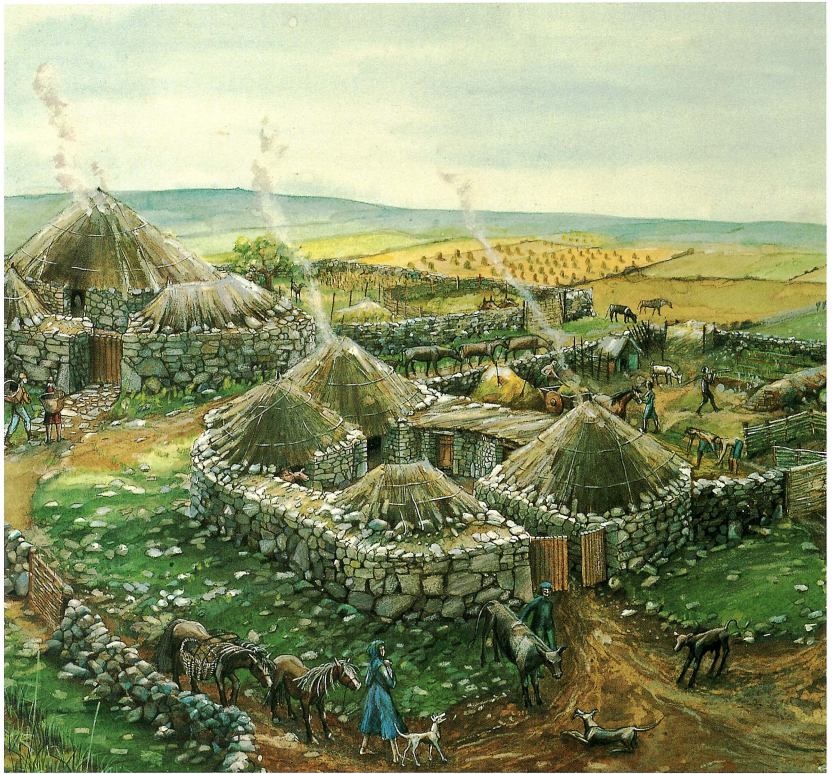
Left: The Romano-British settlement at Milking Gap, from the air. The ruins of five round stone houses lie within and beside the farmyard wall
